COUNTRY	Poland	REPORT	
SUBJECT	Location of Military Airport at Szaryany	DATE DISTR.	22 Dec 61
		NO. PAGES	12
		REFERENCES	
DATE OF INFO.			
PLACE & DATE ACQ			
THIS IS UNEVALUATED INFORMATION			50X1-HUM

POLISH MILITARY AIRFIELD AT SZYMANY (no scale)

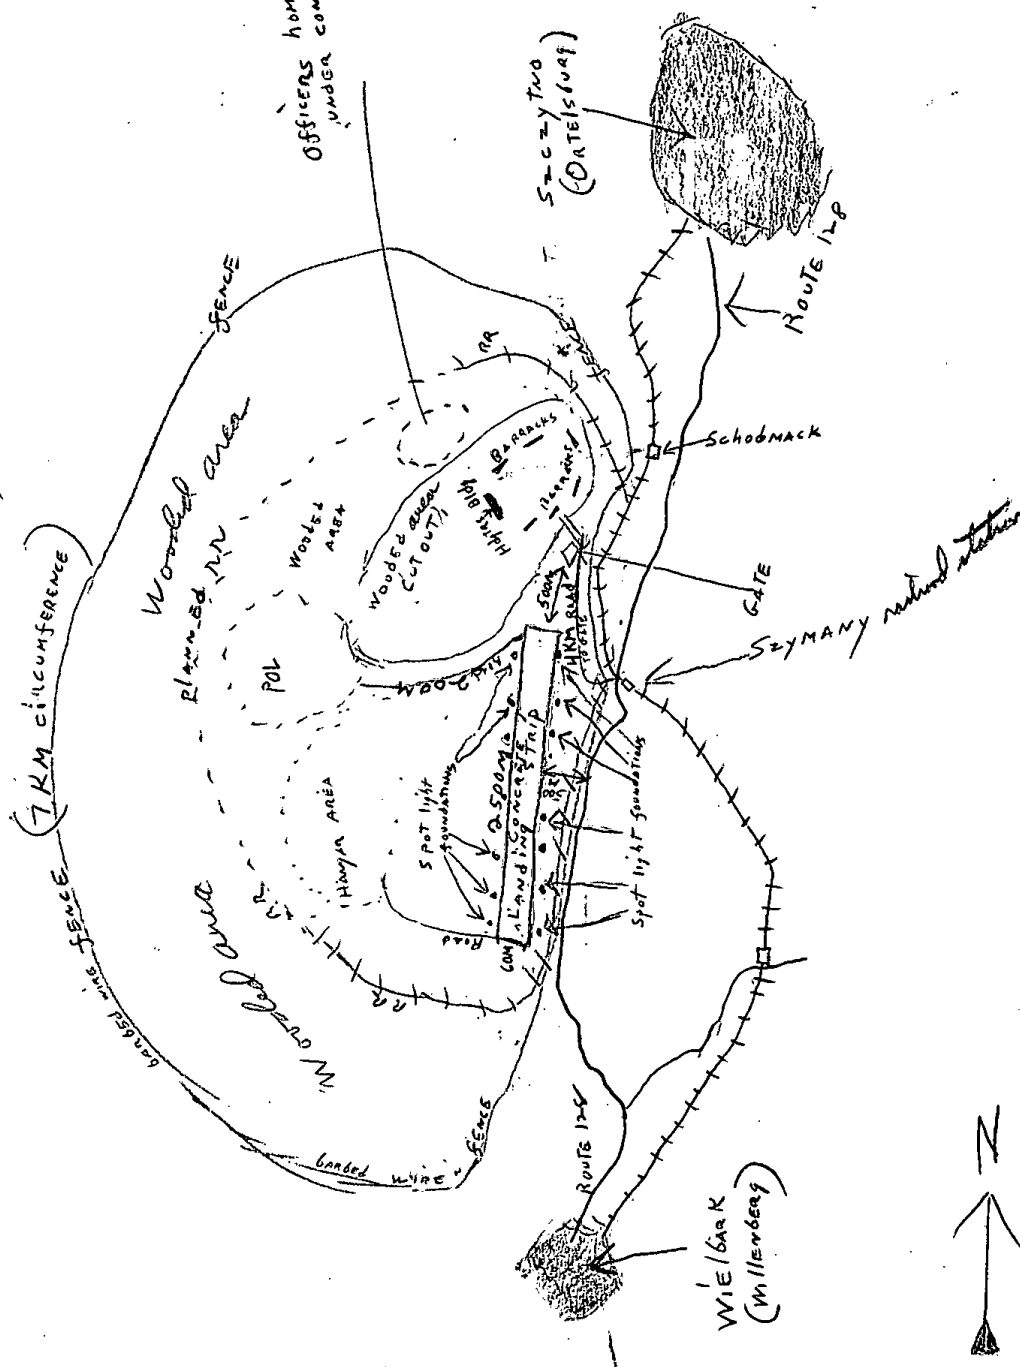
3. The distance from the main road (Route 126) and the railroad crossing to the entrance gate was about four kilometers along a road which also ran close to the railroad tracks. The concrete runway was about 500 meters from the gate and about 500 meters from the main road (Route 126). 50X1-HUM

5. About 200 meters west of the north end of the runway, the area was designated as a PCL storage dump. In 1956 about 18 large tanks were delivered to this area to be placed in the ground.

6. To the south of the POL area and west of the runway, the soldiers were clearing an area where hangars were going to be constructed.
7. Part of a standard gauge track which would eventually circumvent the entire airfield and military compound was also under construction.
8. An electrified barbed-wire fence, about six feet high, surrounded the entire area beyond the railroad track.  the fence was about seven kilometers long.

This military airfield is located at Szymany at grid coordinates 53 29 N  
20 57 E
